Debris/Ice/TPS Assessment And Photographic Analysis For Shuttle Mission STS-43

September 1991

DEBRIS/ICE/TPS ASSESSMENT
AND
PHOTOGRAPHIC ANALYSIS
OF
- SHUTTLE MISSION STS-43

August 2, 1991

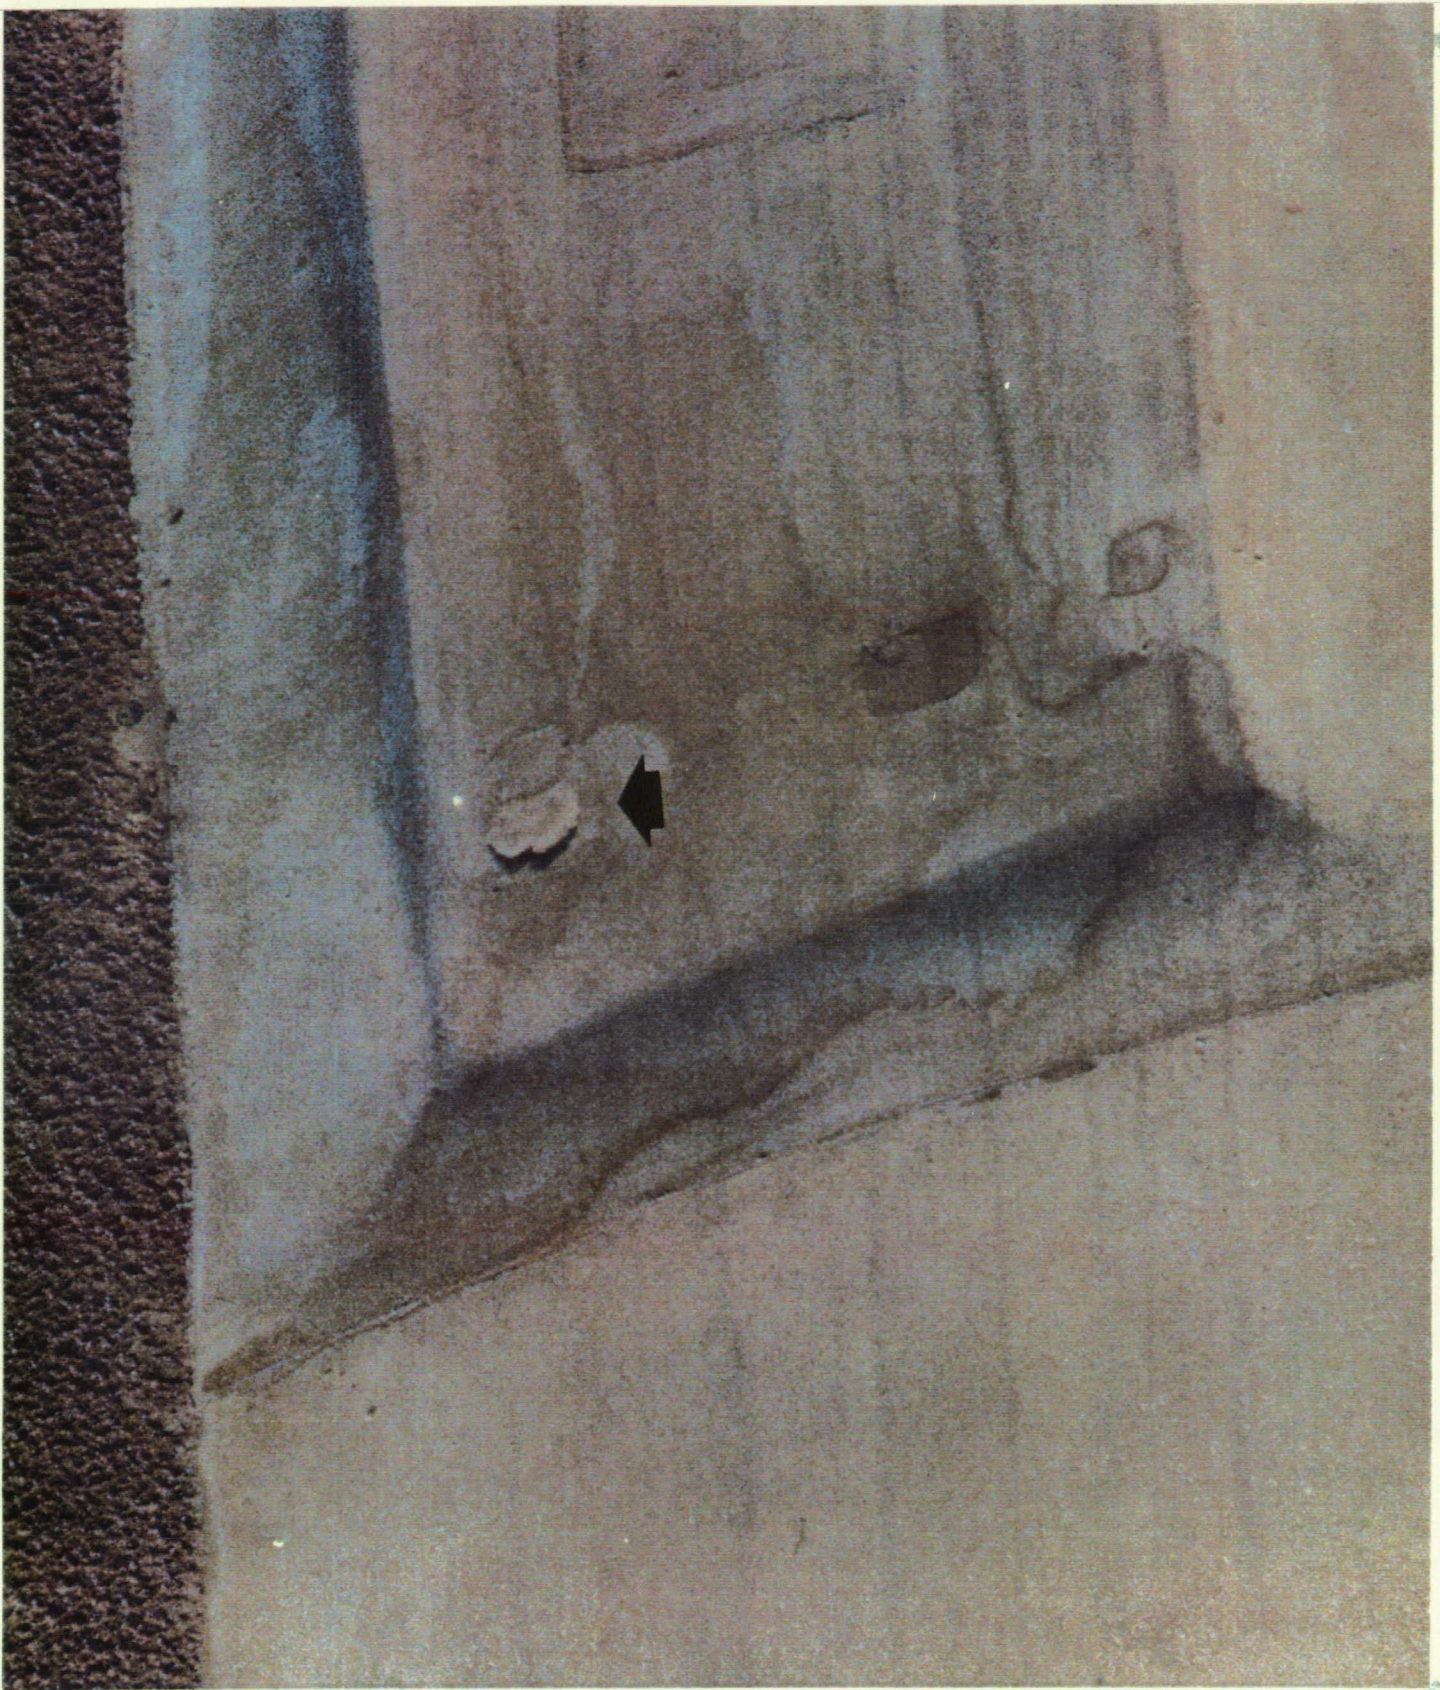
A 1.5"x1" area in the +Y longeron BX-250 adjacent to the aft +Z depth-gage core closeout protruded with 1/8-inch offset. An MRB approved the condition for flight based on acceptance criteria in NSTS-08303.

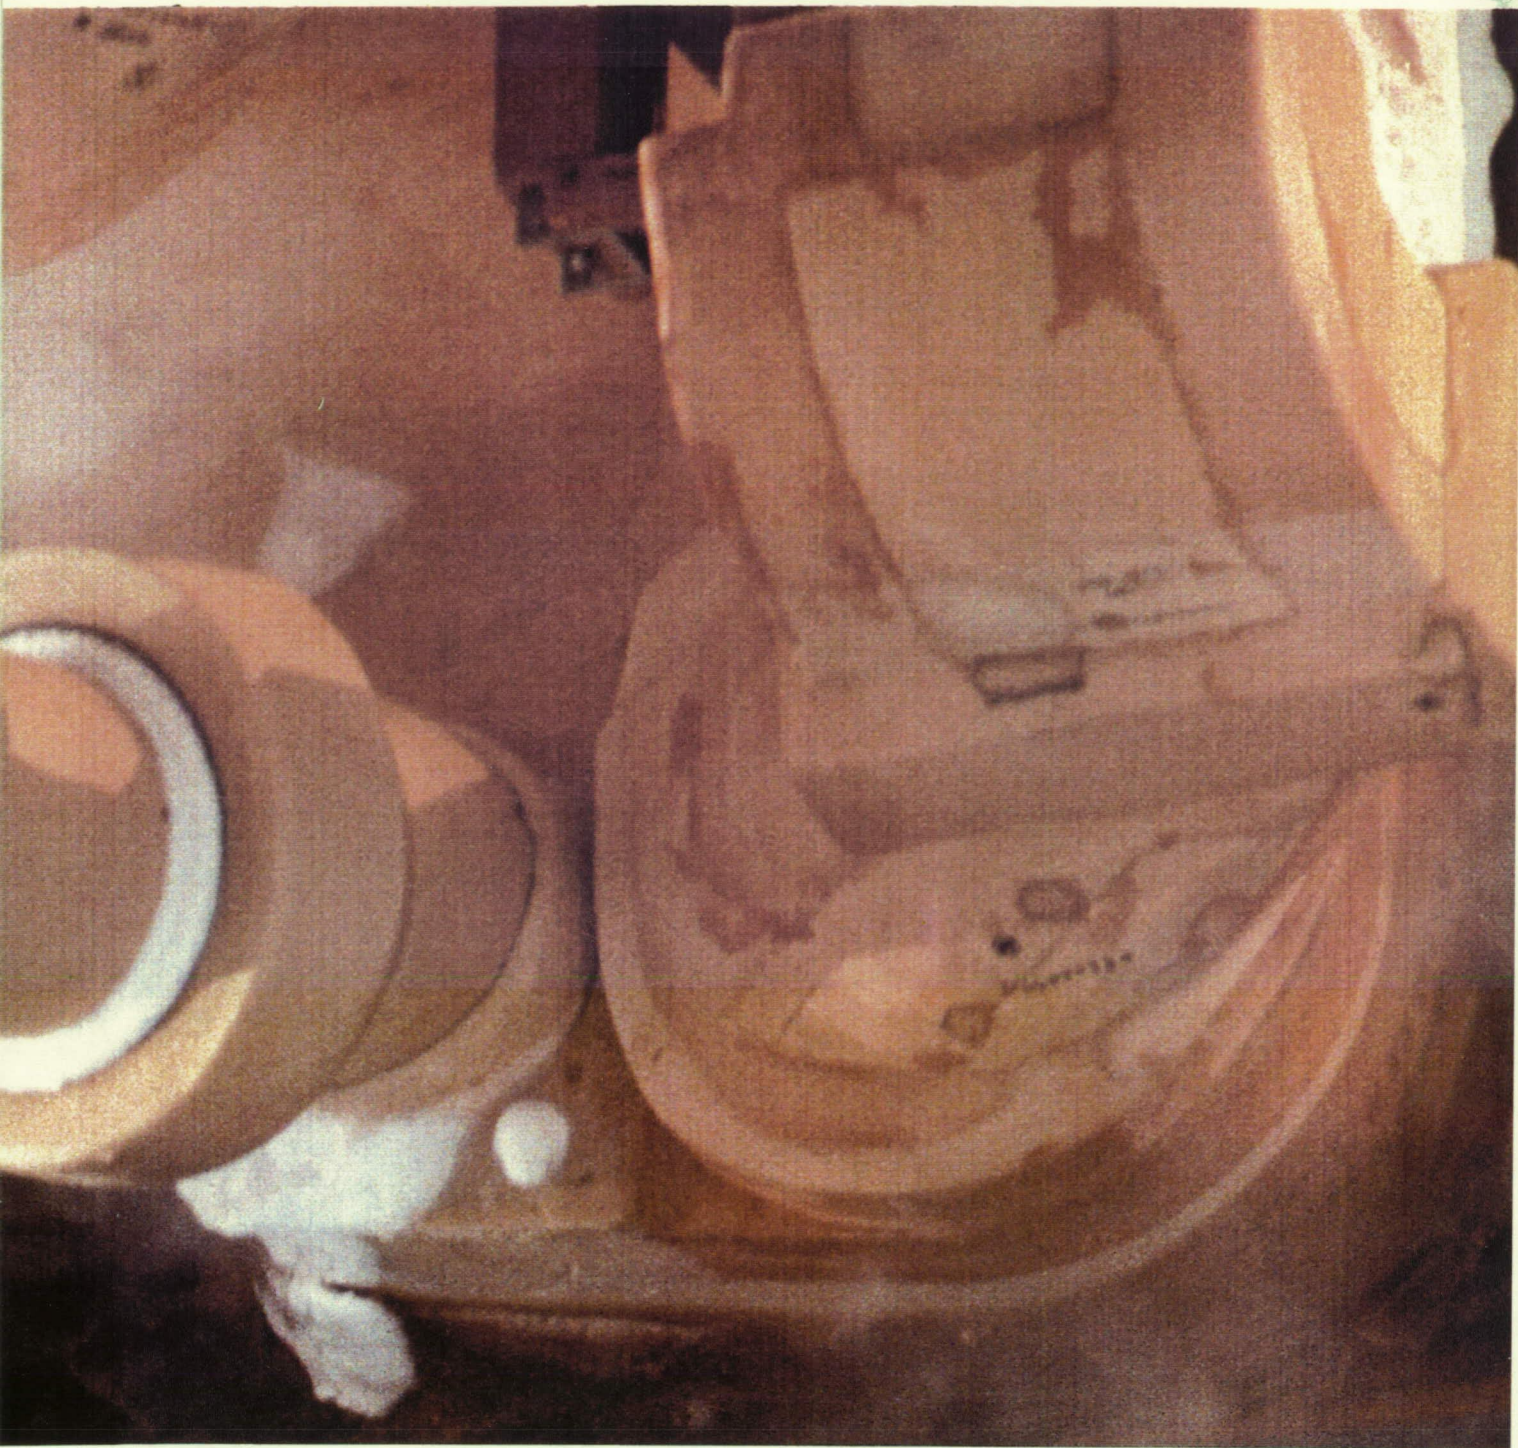
Ice/frost accumulations on the LH2 ET/ORB umbilical outboard side and top sides, plate gap purge vent, and forward outboard pyrotechnic canister purge vent were typical. A small amount of ice/frost had formed along the bondline of the pyro canister closeout (aft side) - an acceptable condition per NSTS-08303.

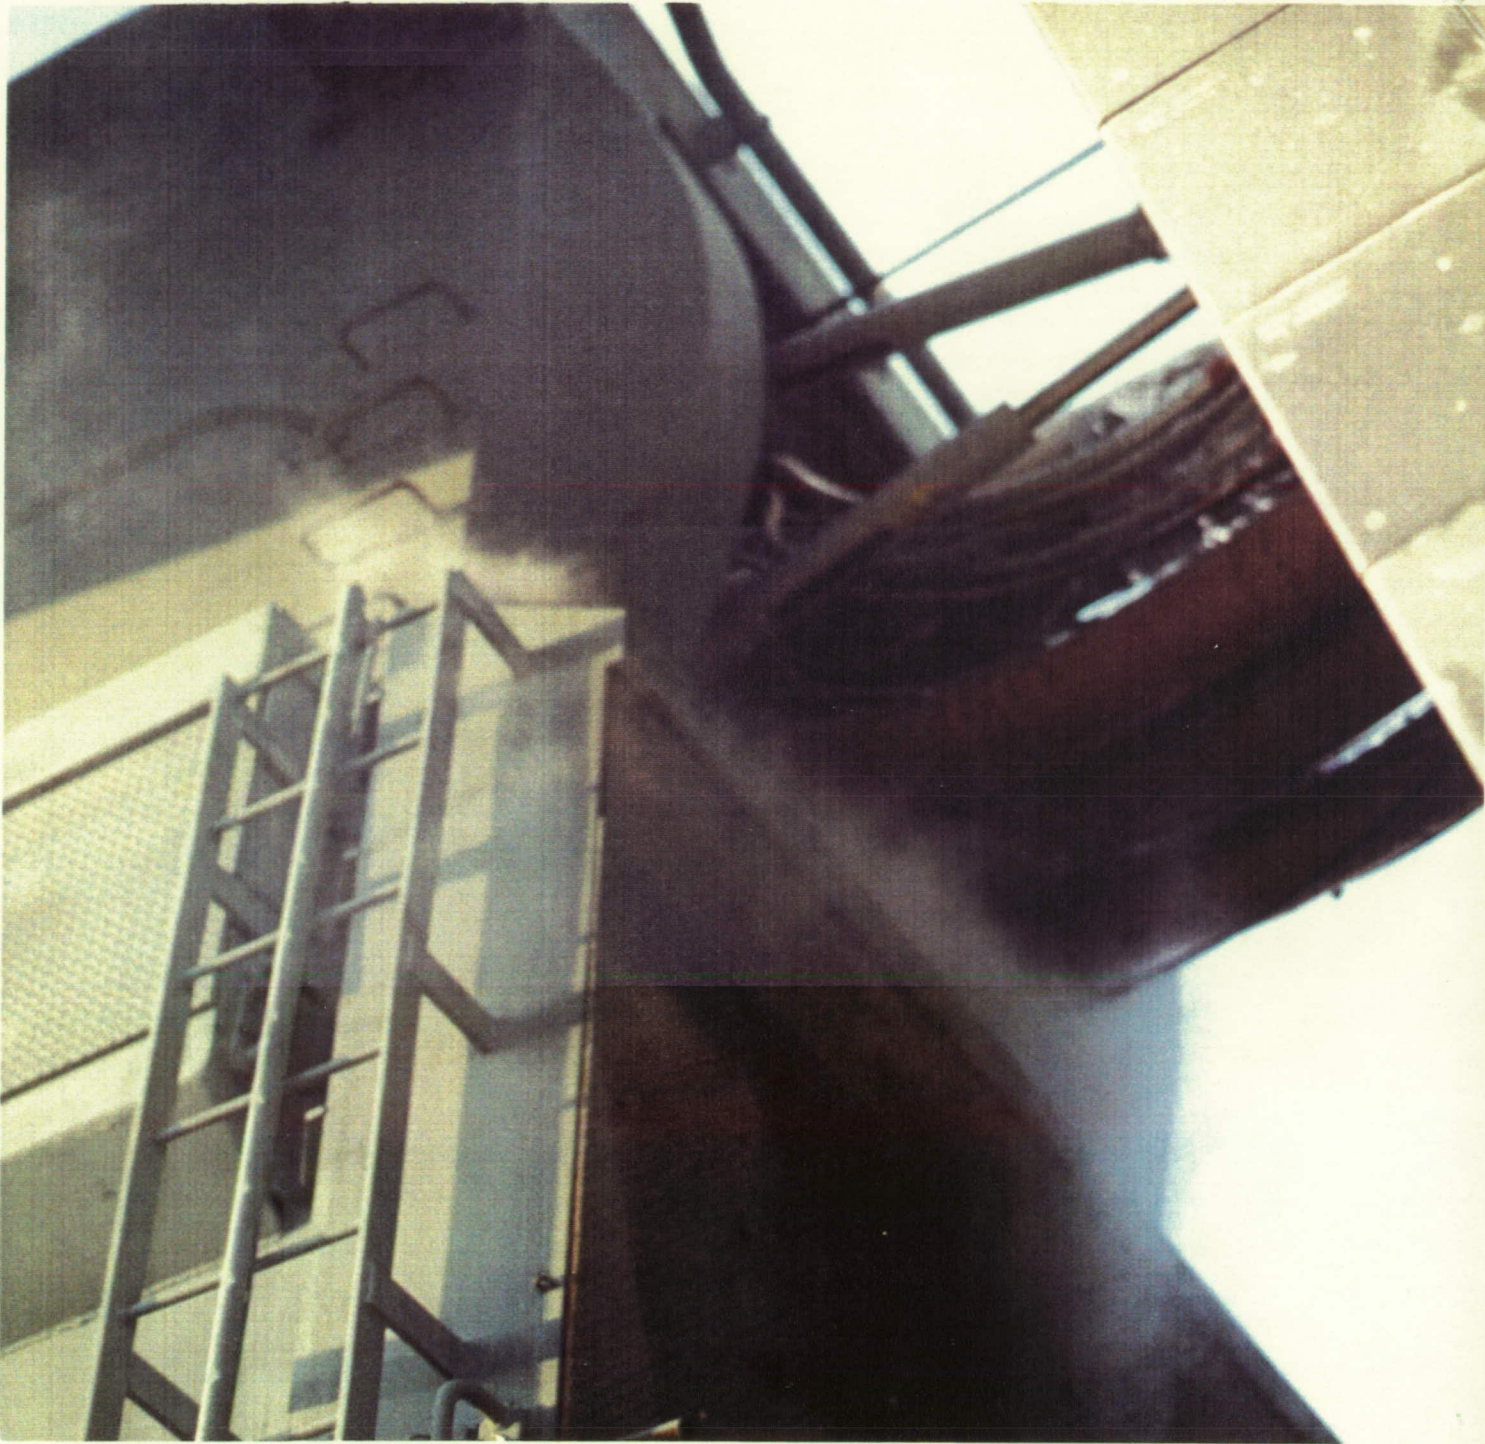
Excessive gaseous oxygen vapors emanated from the open door of the LO2 TSM and a facility IPR was taken against a suspected liquid oxygen leak inside the TSM

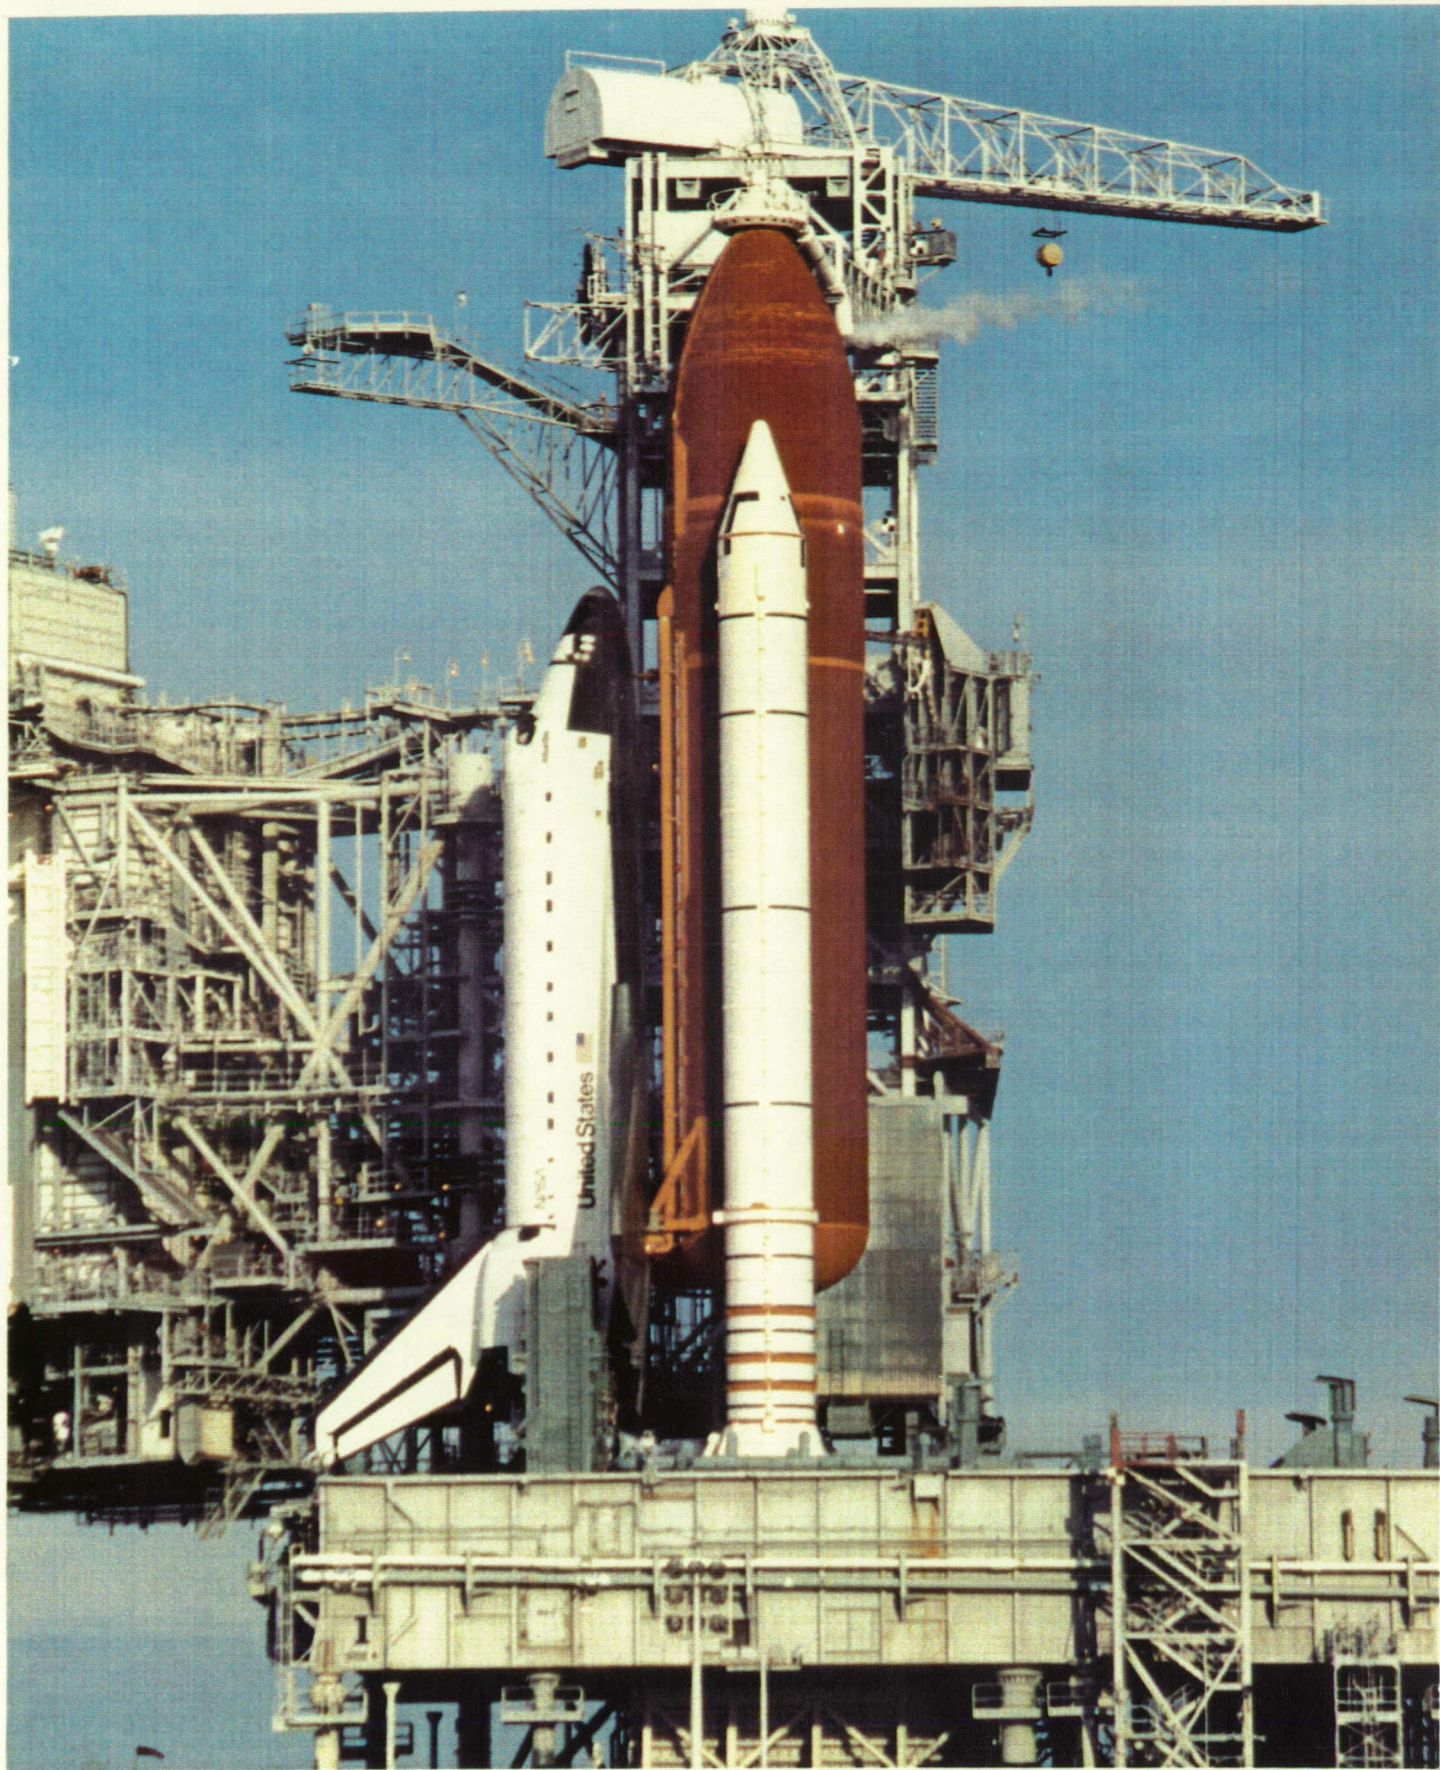
Infrared scanners measured LO2 TSM wall temperatures an average of 8 degrees cooler than similar places on the LH2 TSM walls. In addition, condensate was present on the LO2 TSM walls from the MLP deck level to half the height of the TSM. The launch team determined a liquid oxygen leak inside the TSM would not be a constraint to launch.

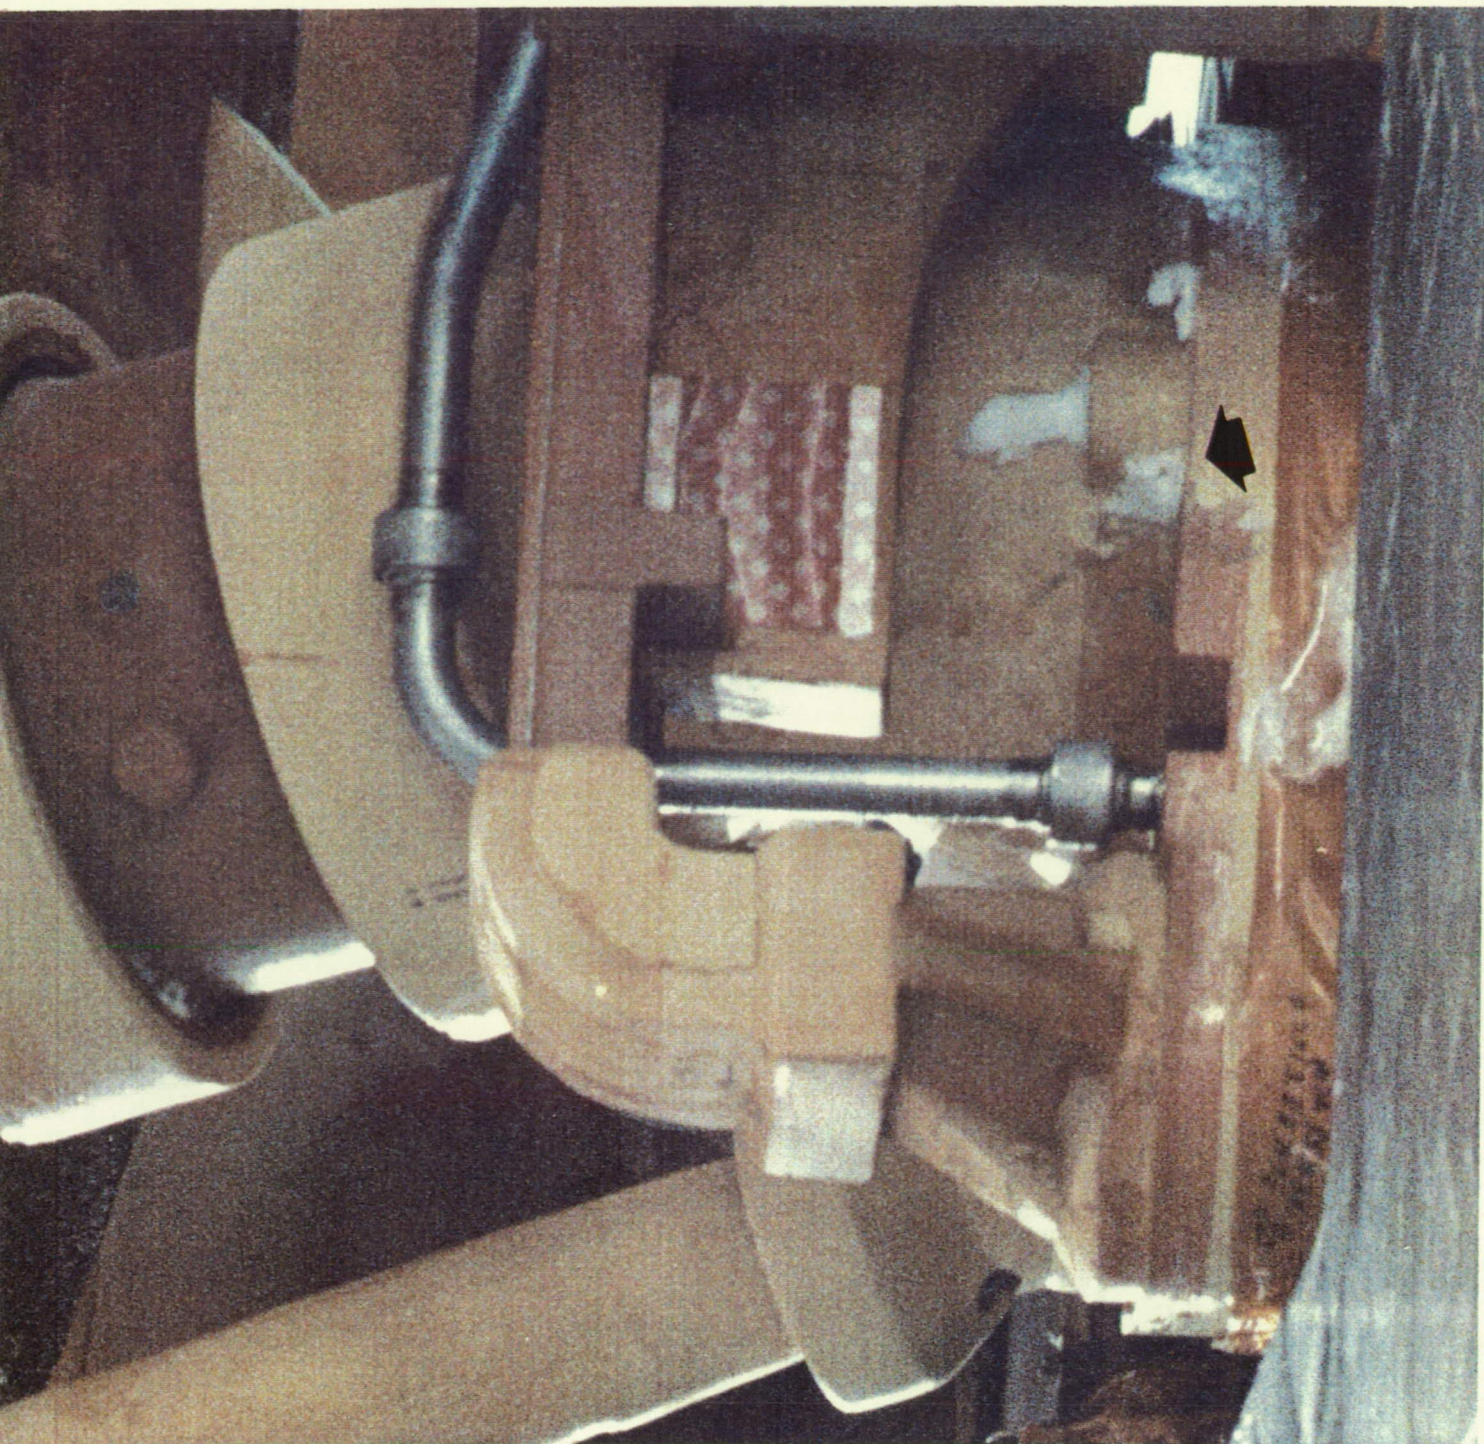
The LH2 ET/ORB umbilical exhibited no TPS anomalies or unusual ice/frost accumulations after cryo load with the exception of an ice/frost formation along the bondline of the forward outboard pyro canister closeout (aft side). This condition was acceptable per NSTS-08303.

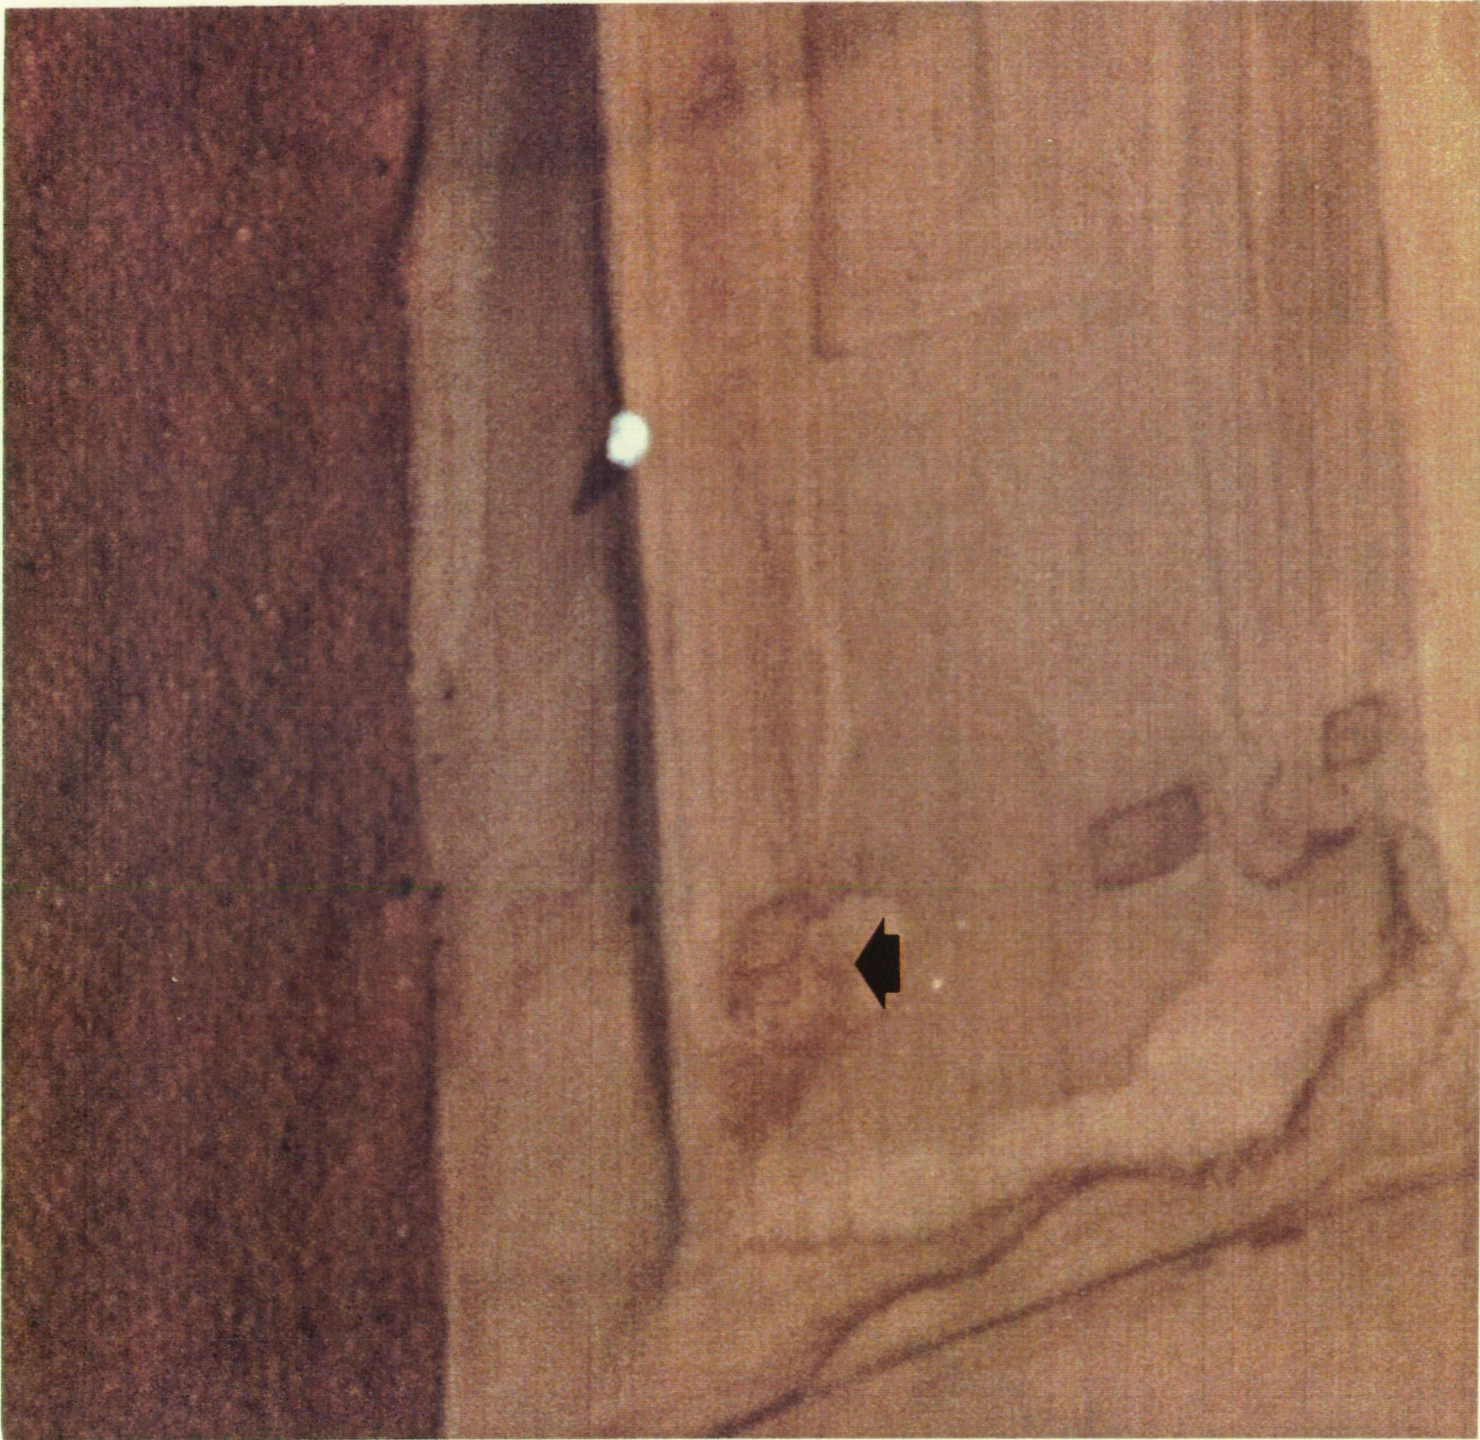
A small frost spot formed along a knit line (no crack in the TPS) on the +Y longeron, but no ice or frost was present on the area that had previously delaminated (arrow).

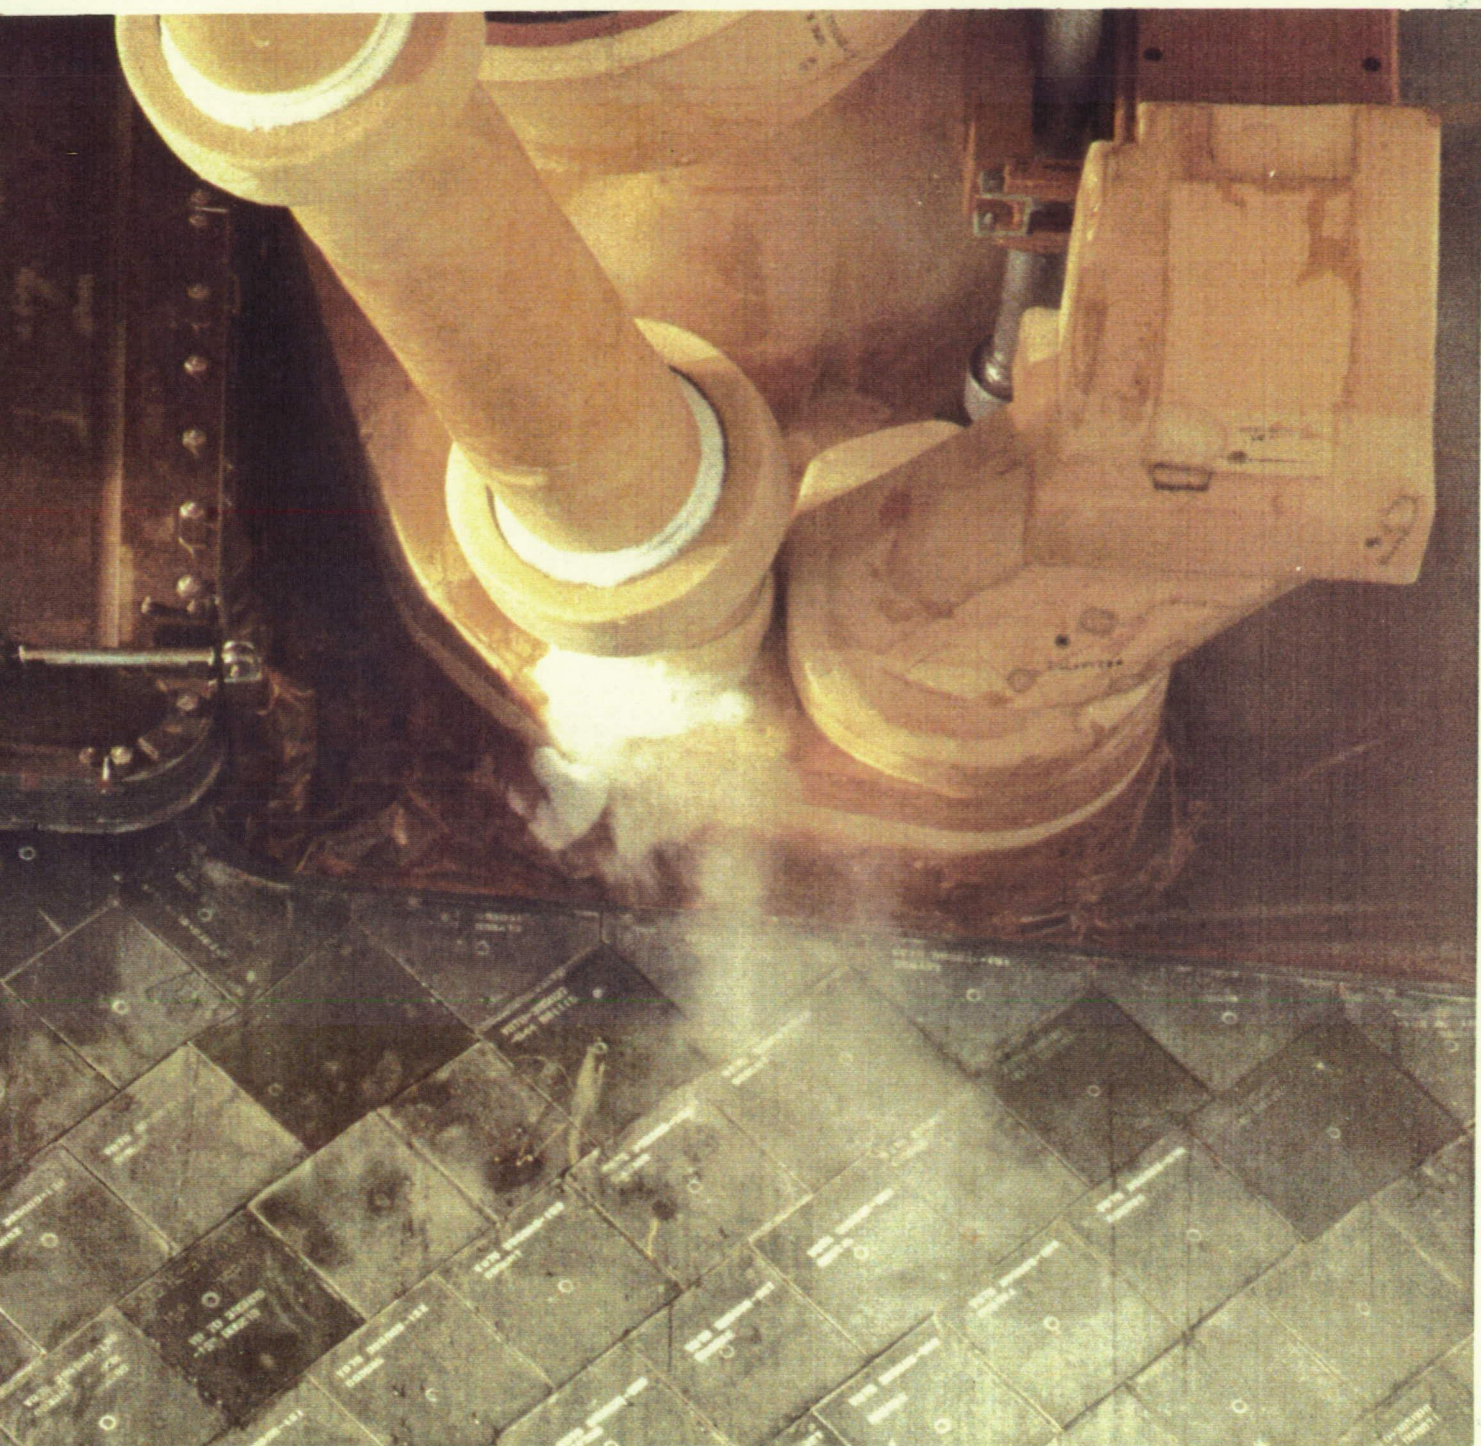
Atmospheric conditions (high humidity) caused condensate to drip from the LH2 ET/ORB umbilical onto Orbiter tiles. Normal venting of cold helium purge gas, more visible than usual, occurred during tanking, stable replenish, and launch.

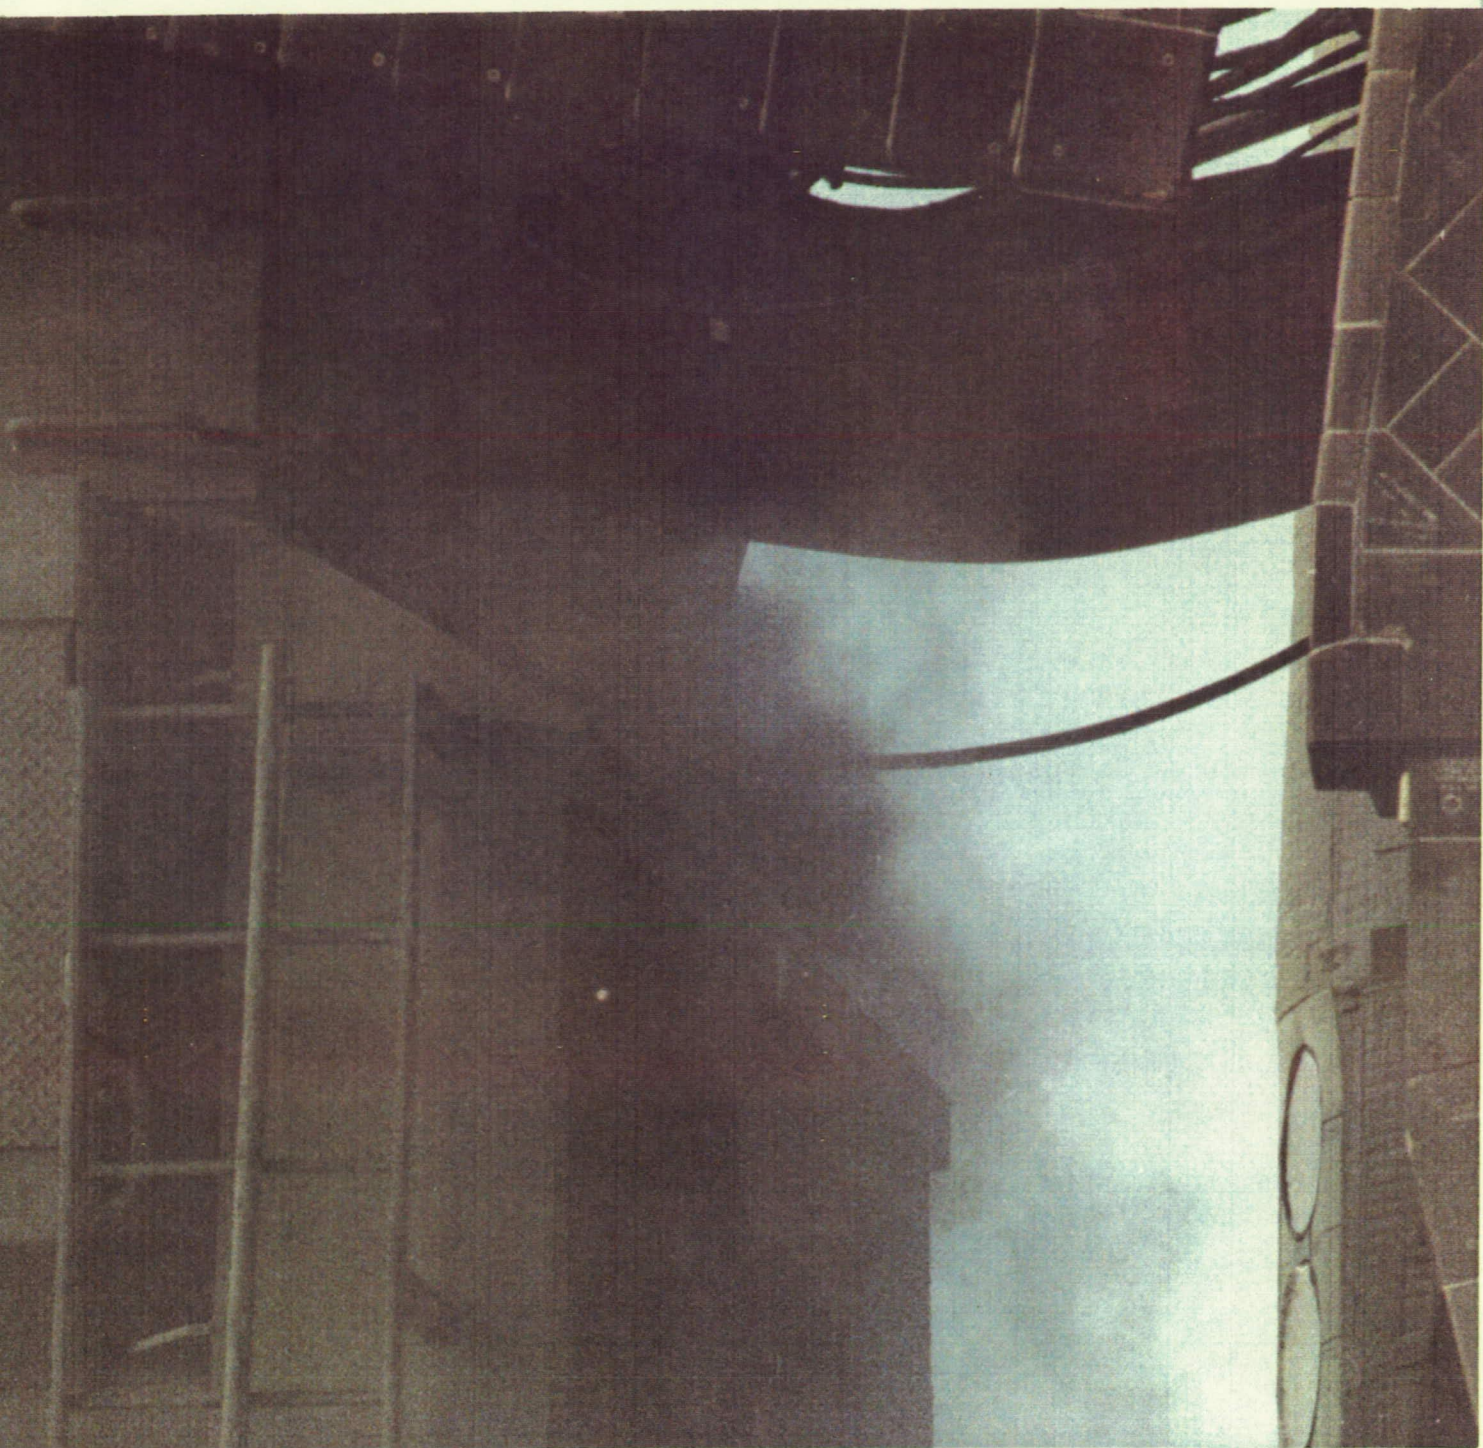
One hour into cryo load, 15 drips with vapor trails fell from the LH2 ET/ORB umbilical-to-recirculation line interface area. There was no evidence of a blowing leak, nor did the drips appear for a consistent, frequent, or extended duration. The drips behaved like liquid air rather than hydrogen. Since that area had just chilled down due to the start of recirculation, the source of the cryogenic drips was a small TPS void or defect that had cryopumped locally for a short period of time.

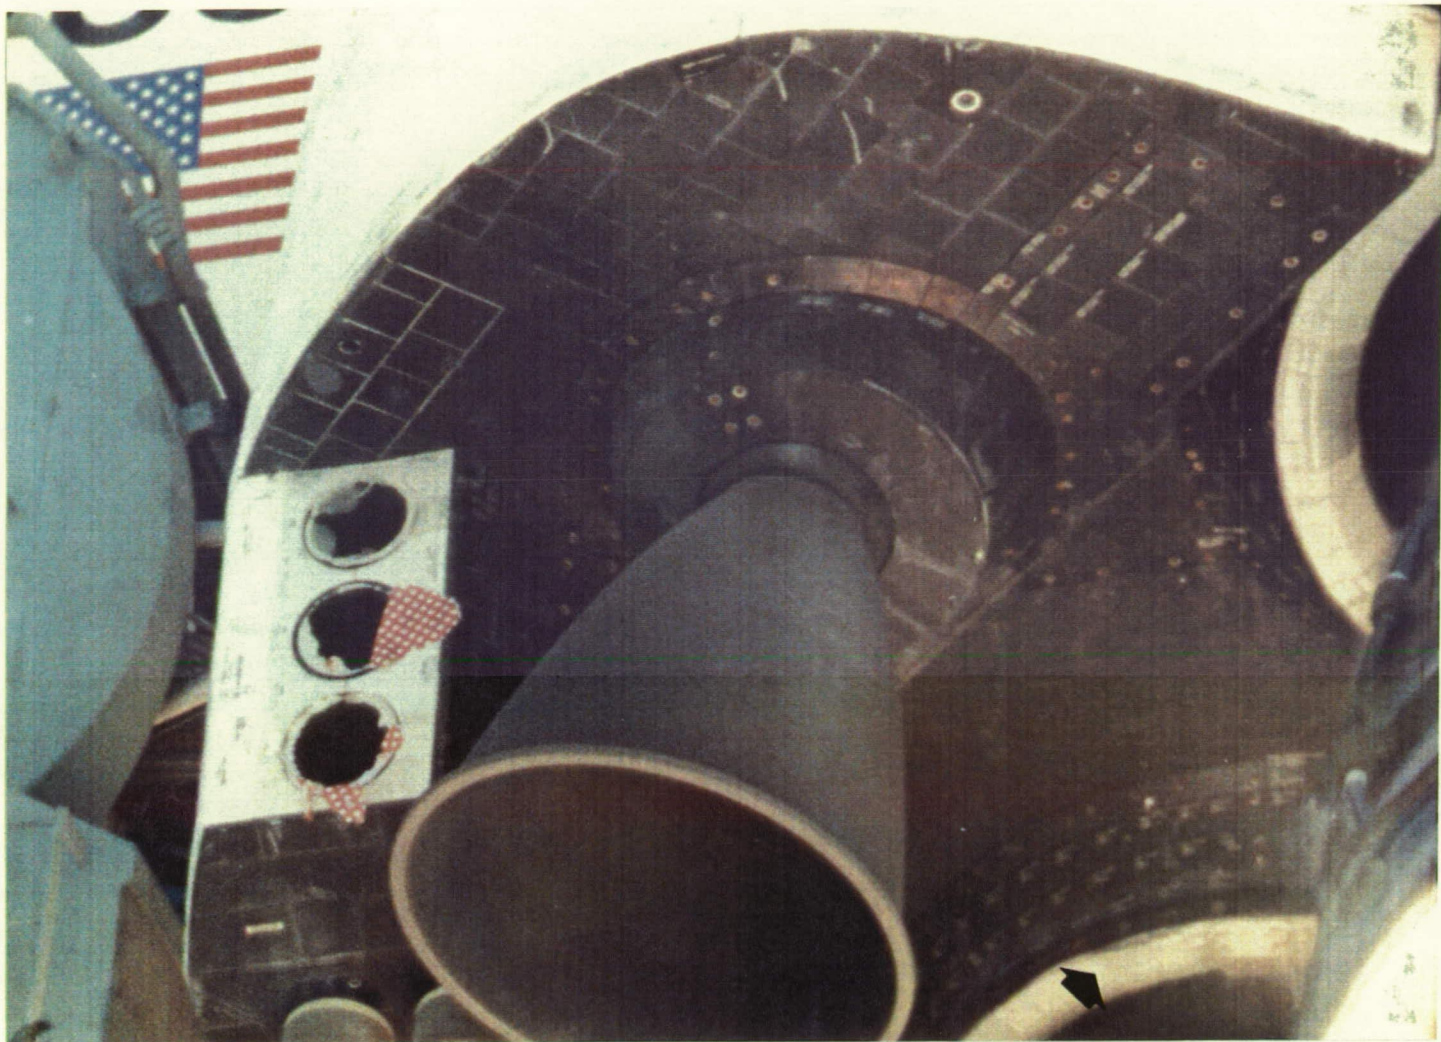
The SSME #2 closeout blanket was pulled loose or torn along the outer perimeter at the 11 o'clock position during SSME ignition. The separation was approximately 10 inches in length and occurred near the blanket splice. Post landing inspection revealed the outer layer of that ten inch section was missing.

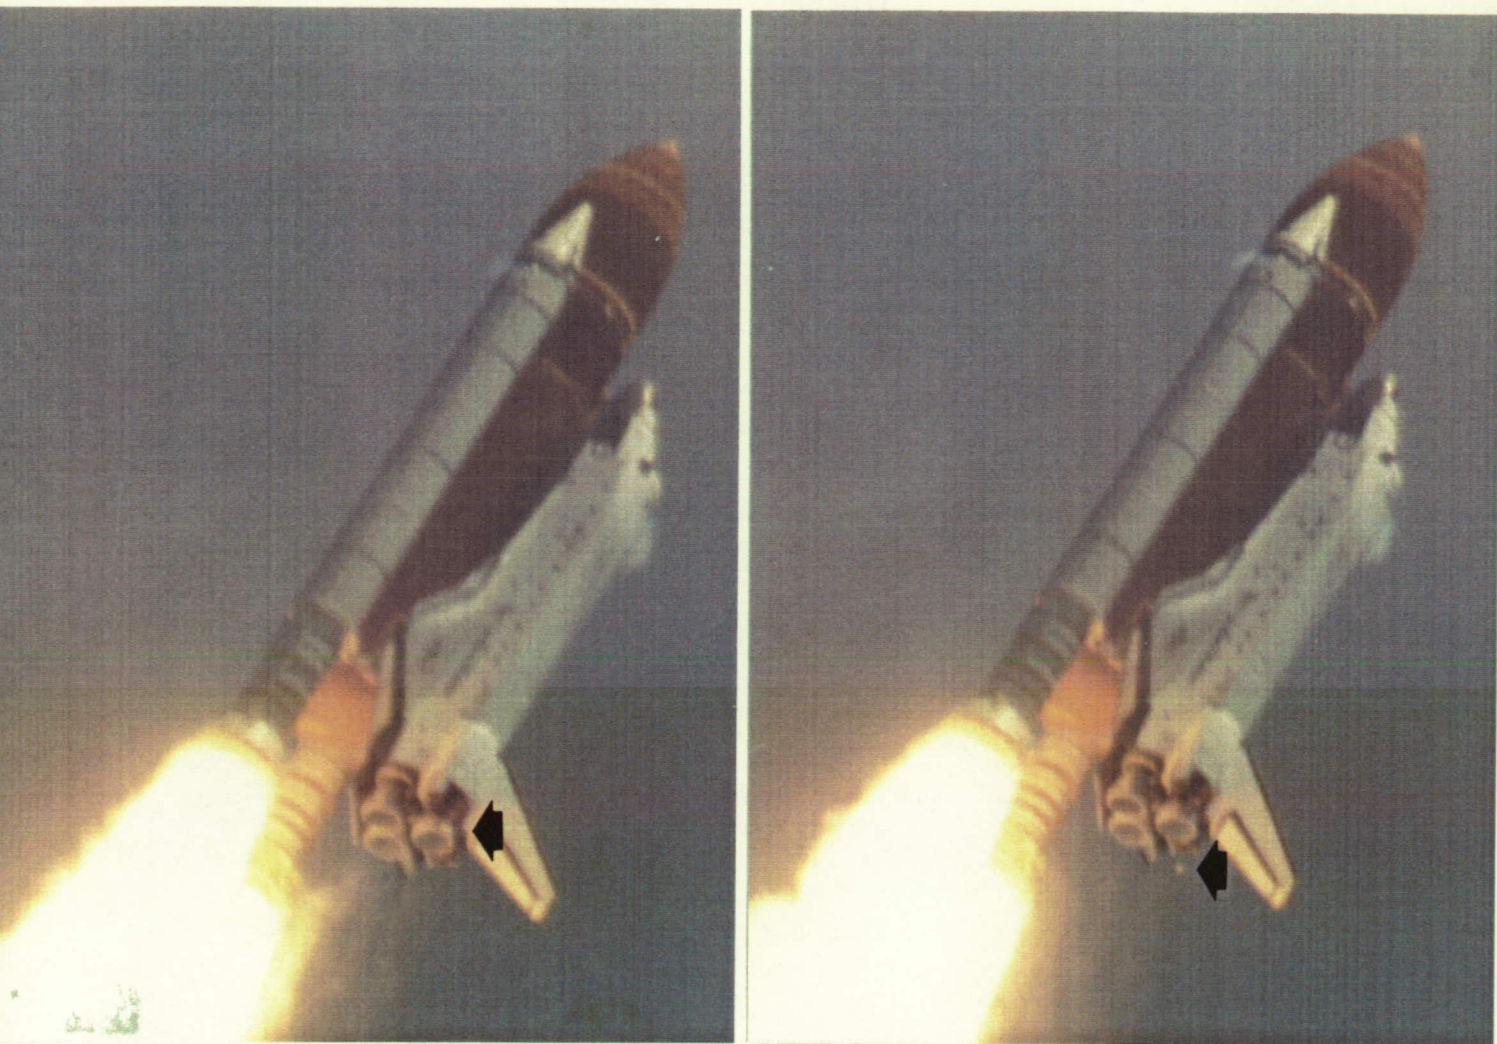
A white object fell from the aft end of the Orbiter at T+43 seconds MET. The object, believed to be a section of the SSME closeout blanket, appeared to originate between SSME #1 and #2, moved passed the SSME #1 nozzle (arrow), and fell aft of the vehicle.
